# FTIR Analyses of Hypervelocity Impact Deposits: DebriSat Tests

March 27, 2015

Aerospace Technical Operating Report No.  
TOR-2015-00941

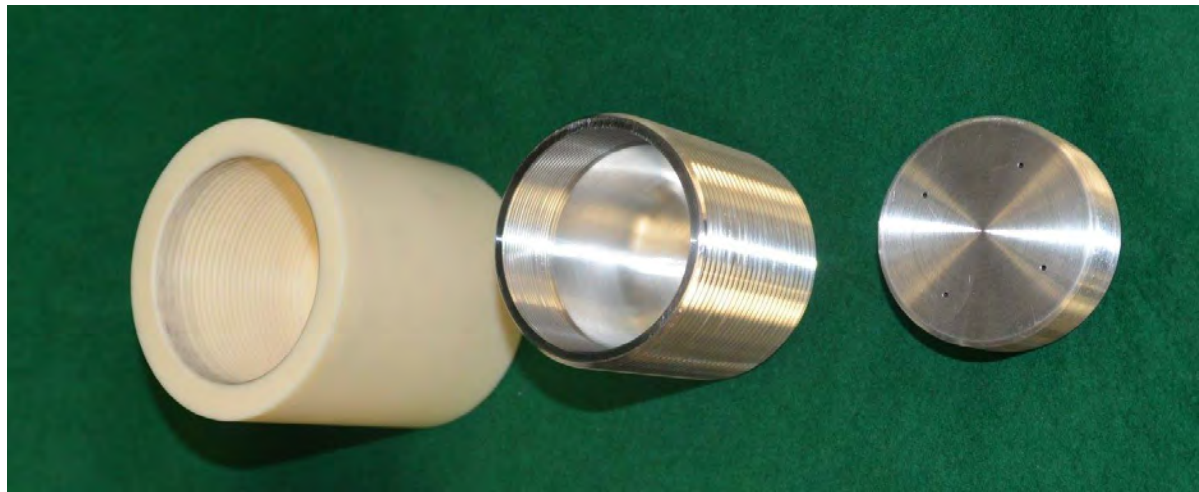
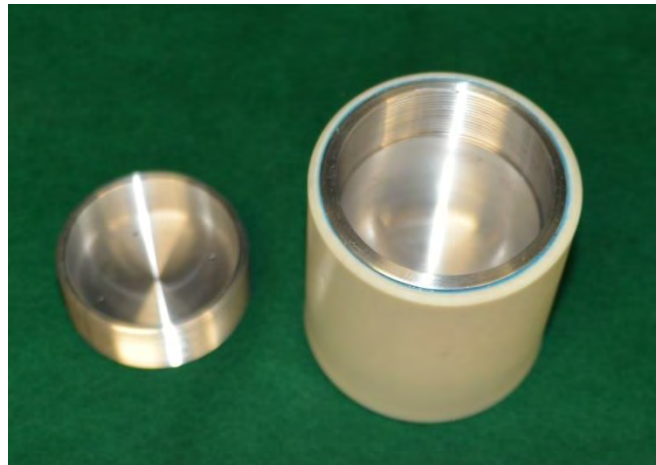
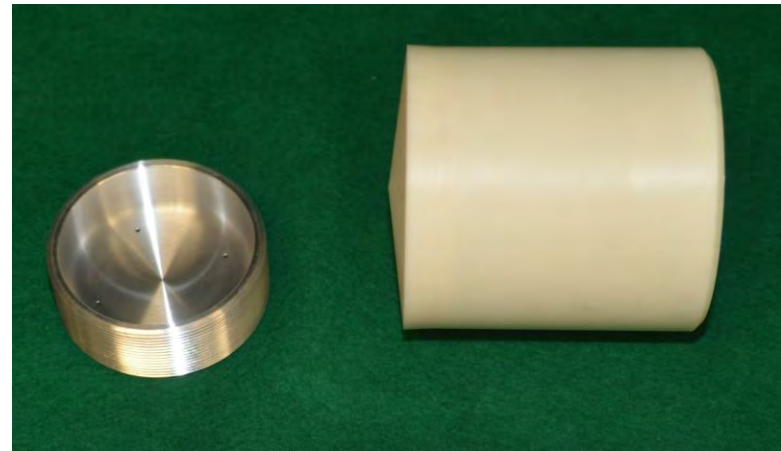
# Projectile

Hollow aluminum and Nylon cylinders. Constructed from three pieces:  
Outer Nylon shell (sabot) with aluminum inserts.  
~600 grams, 8.6 cm diameter X 10.3 cm long – size of a “coke can”

Same type of projectile was used for all three tests.

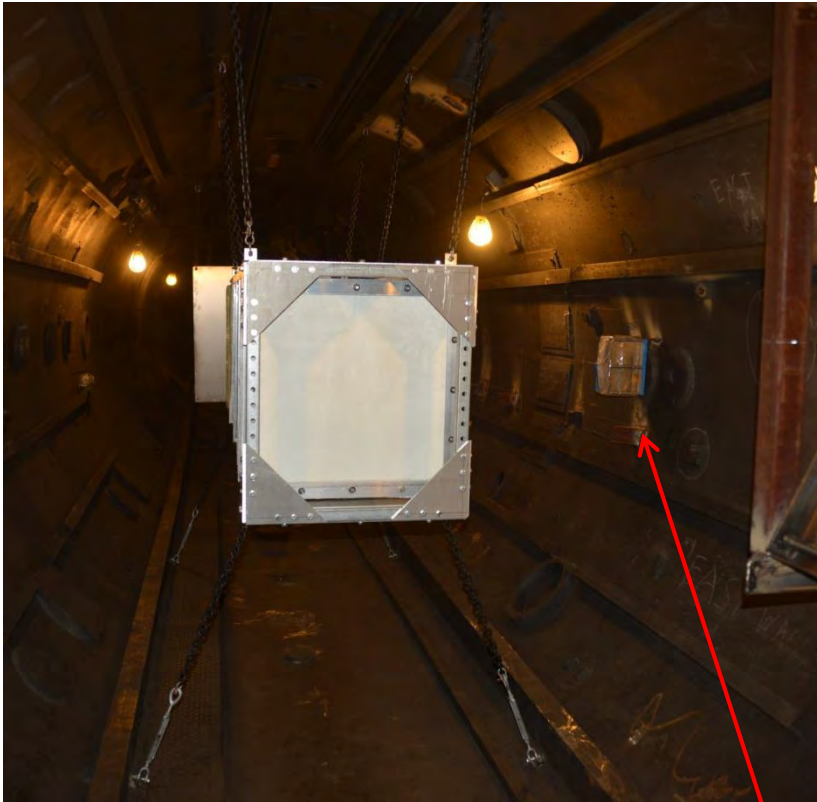
## Looking Down Range

Fiberglass panel in front.

Witness Plate Covered in Plastic at Right

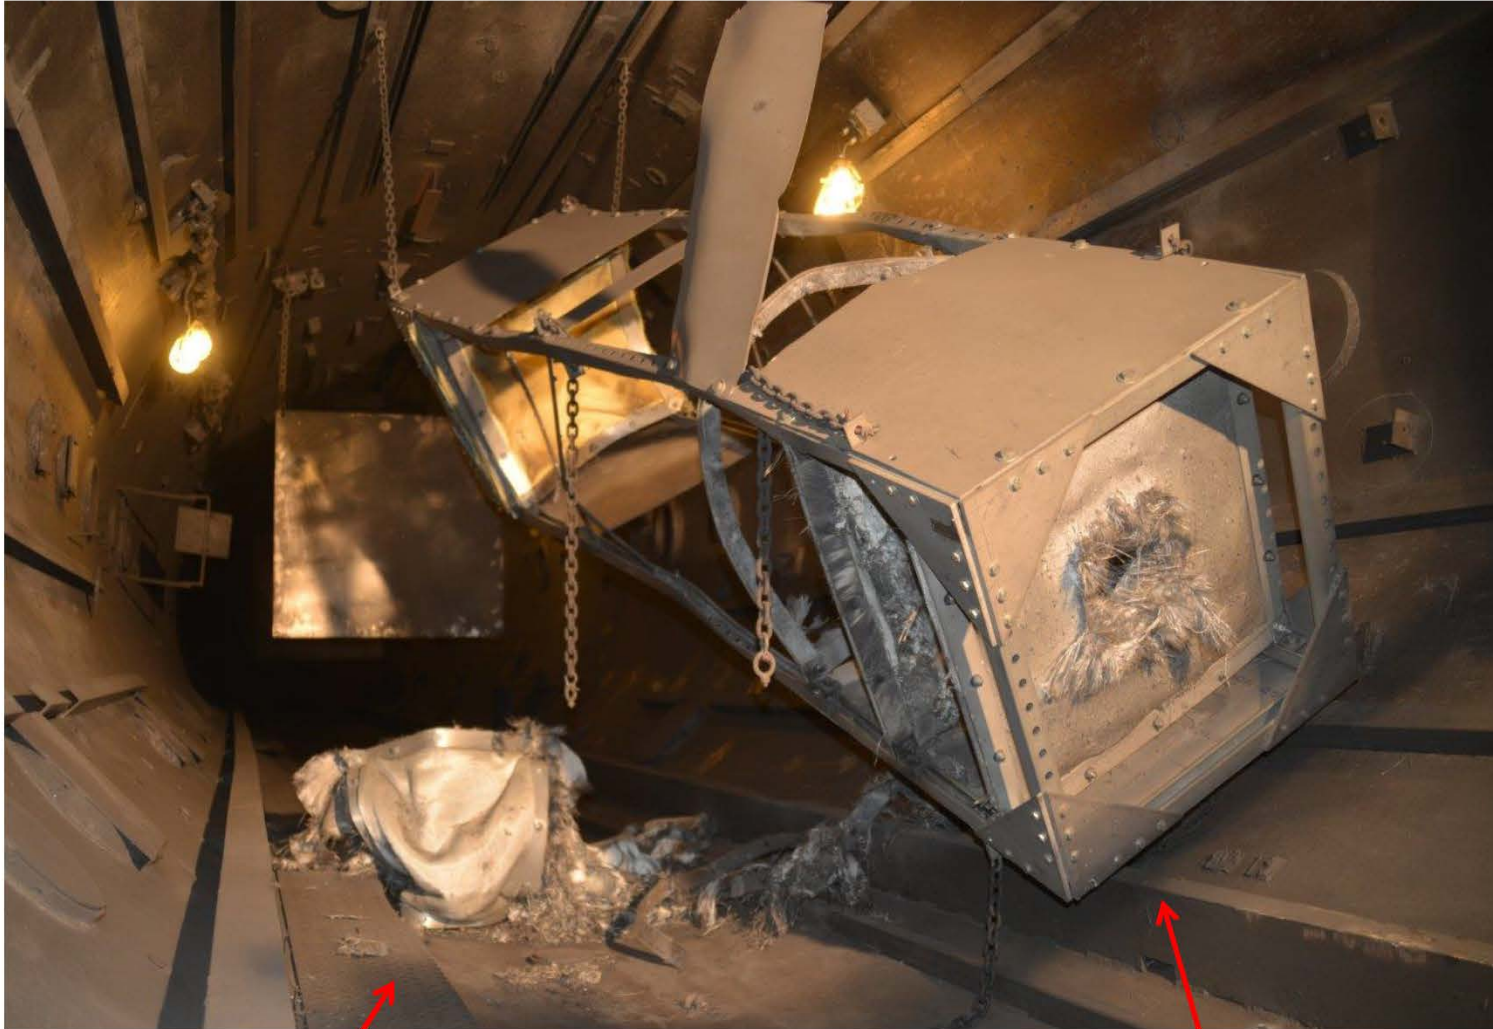
# Target - Post Test

4<sup>th</sup> and 5<sup>th</sup> bumpers dislocated from frame.  
No penetration.

First 3 bumpers penetrated

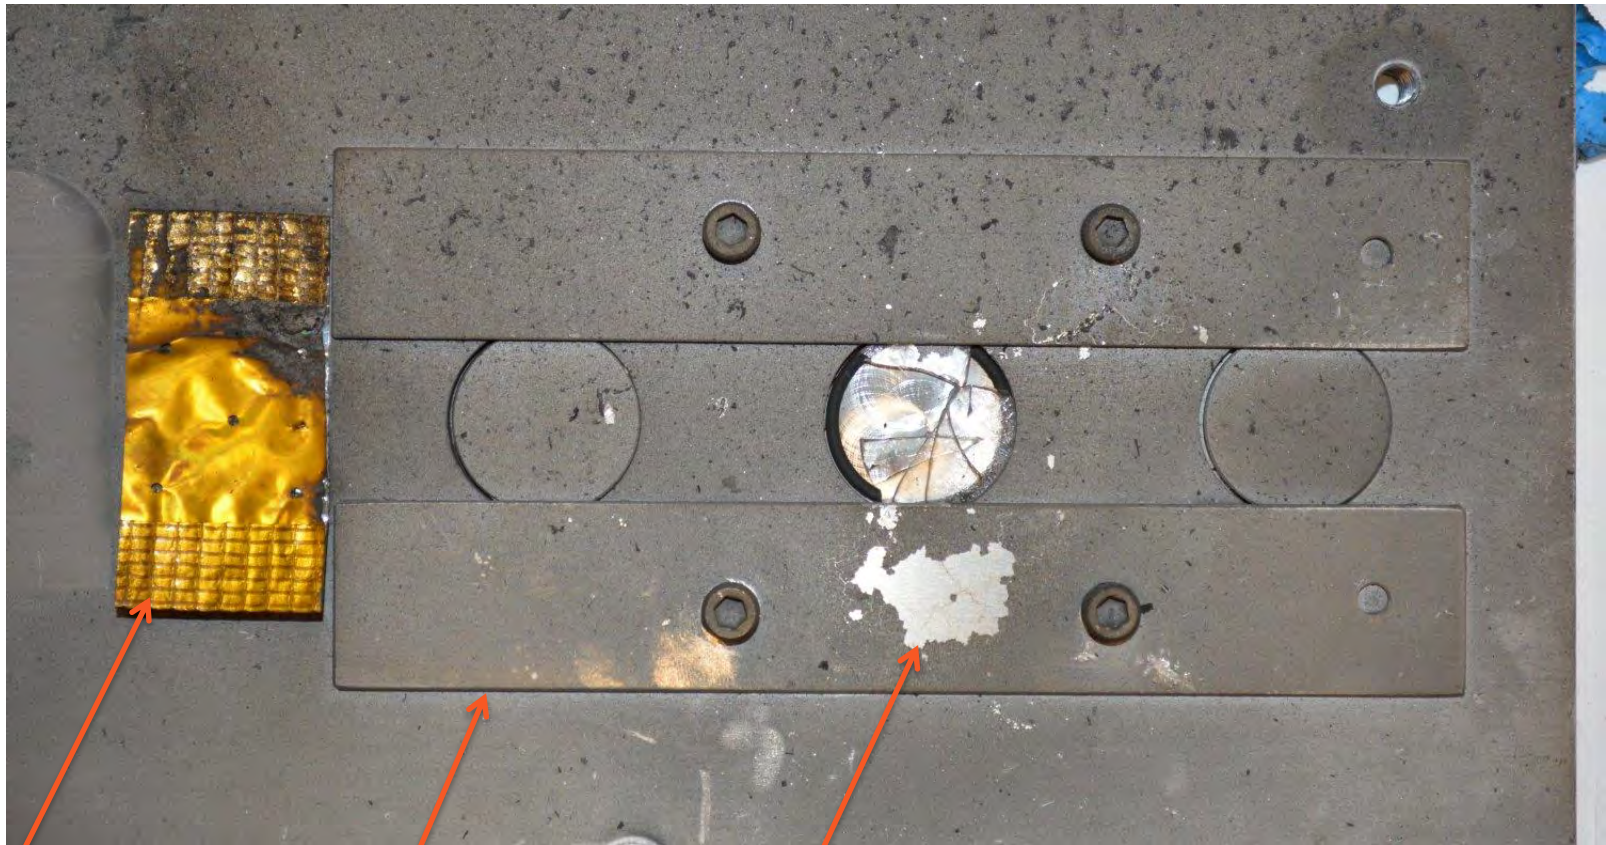
# Witness Plates: Post Test (unprotected)

Note blistered coating flaked off and  
fractured quartz window

Exposed surfaces are covered with a matte gray coating and fine debris

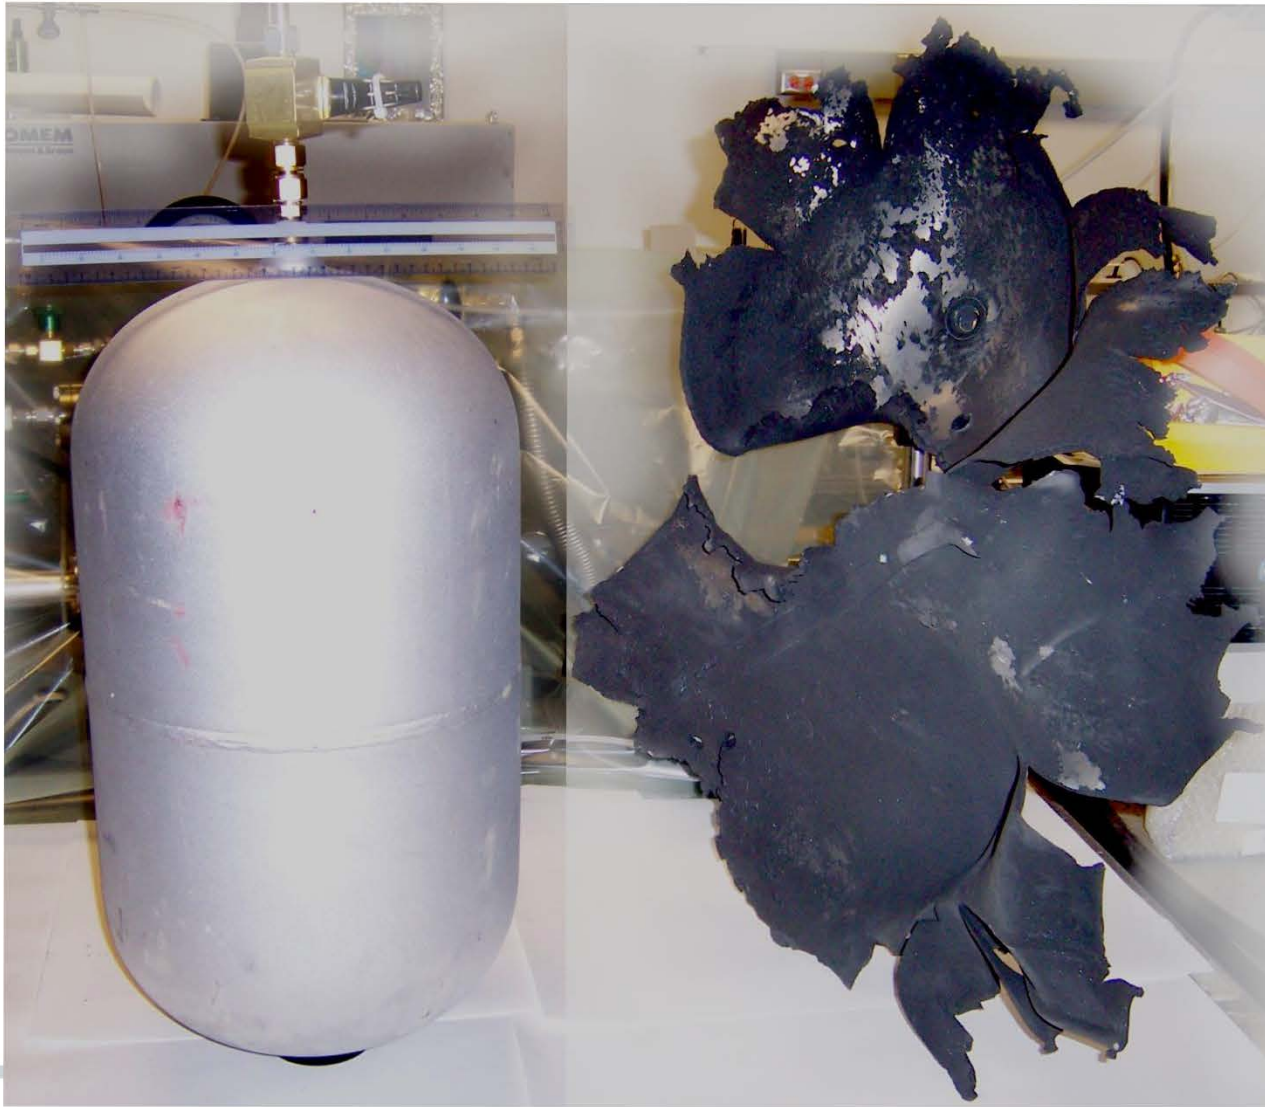
# Main aluminum tank

Before

After impact

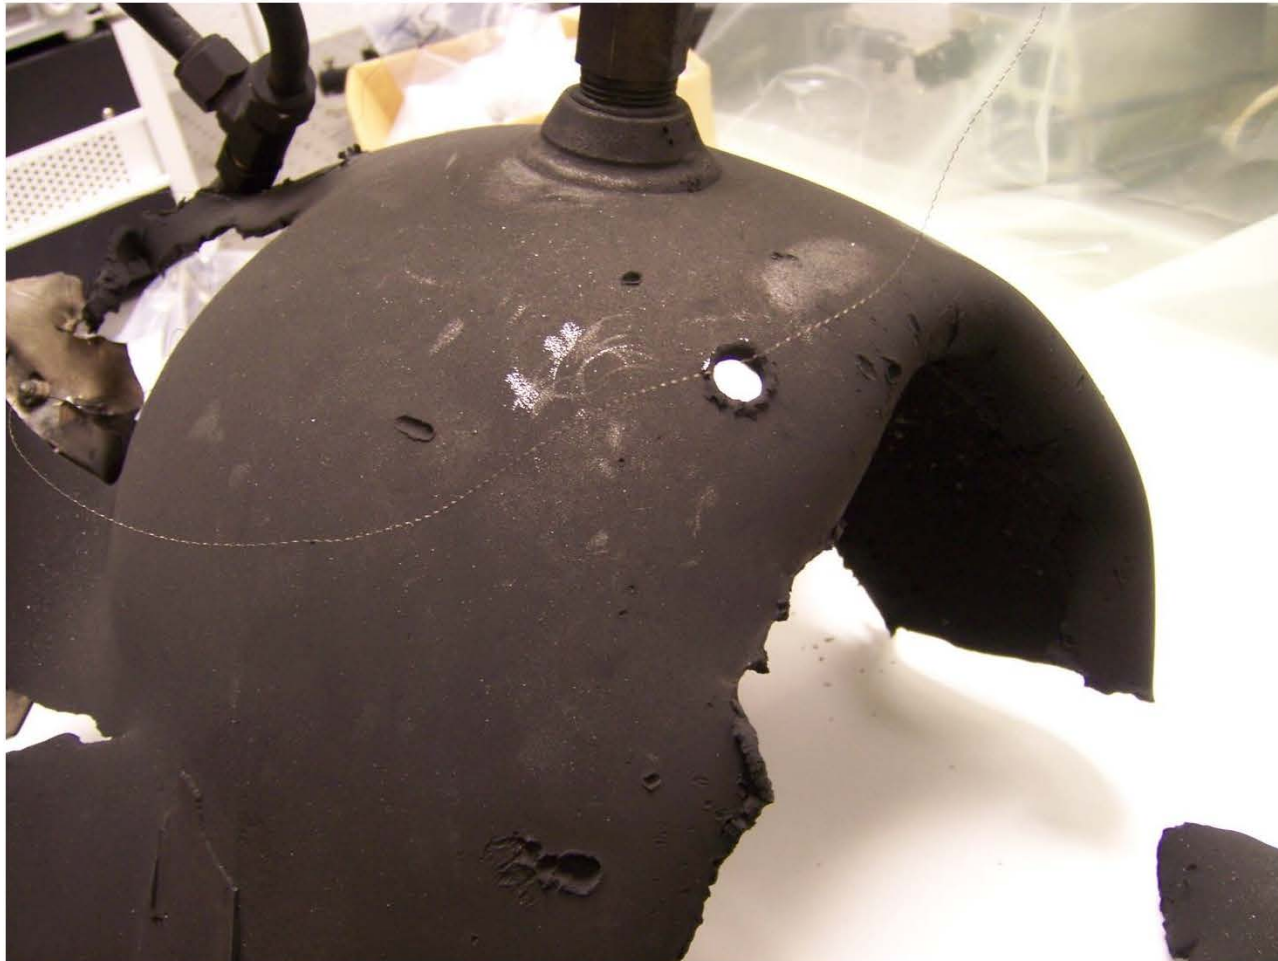
# Main aluminum tank: Post test

Outer and inner surfaces covered with a dark coating

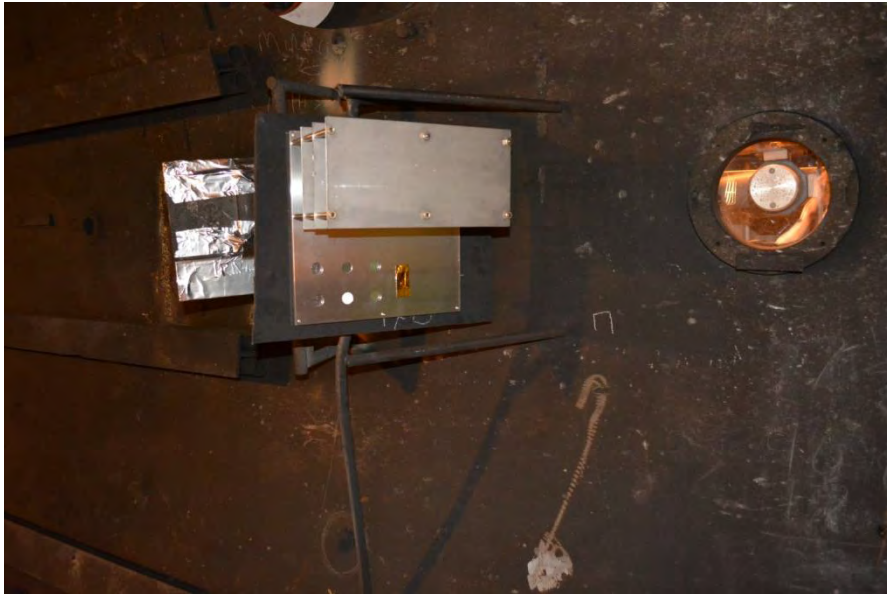
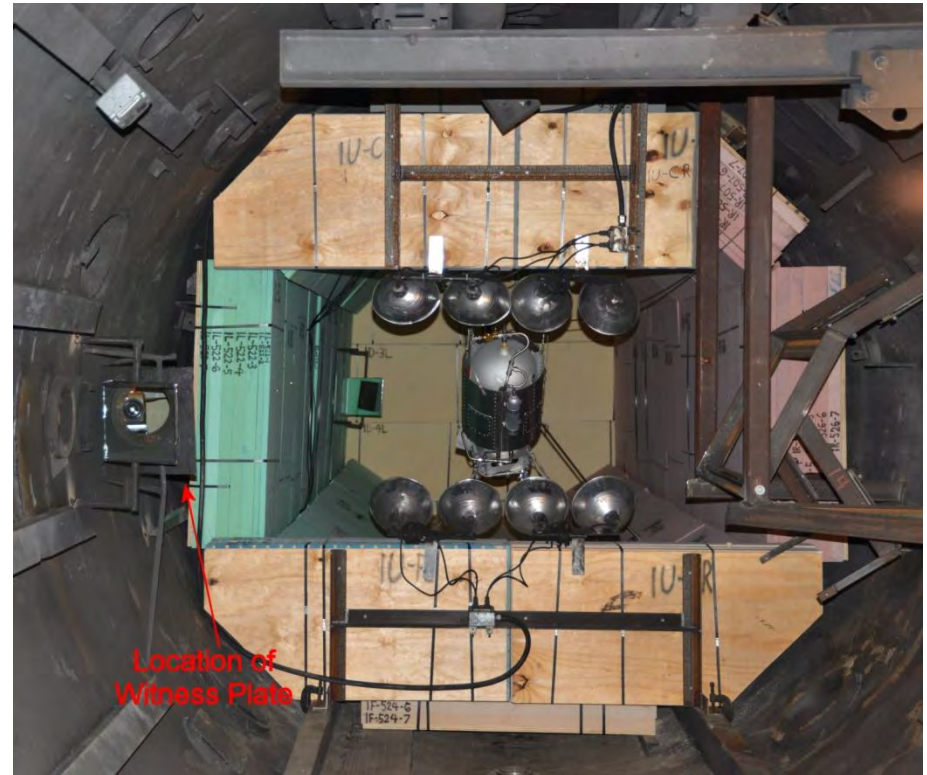
# Witness plates installed in chamber

Witness plate assembly installed about 2-3 meters up range of Debris-LV

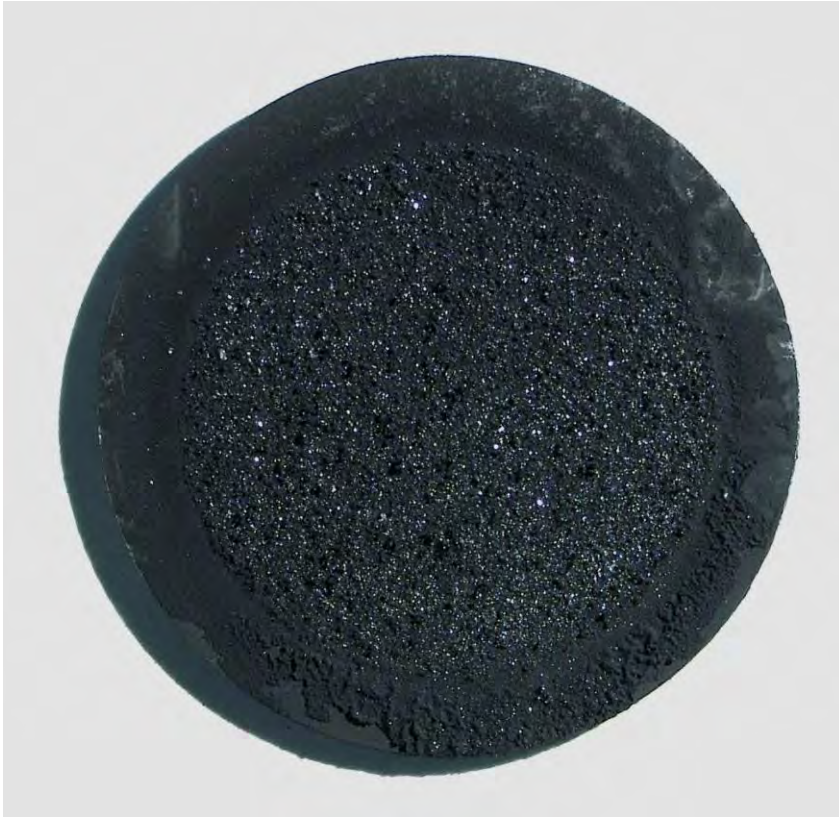
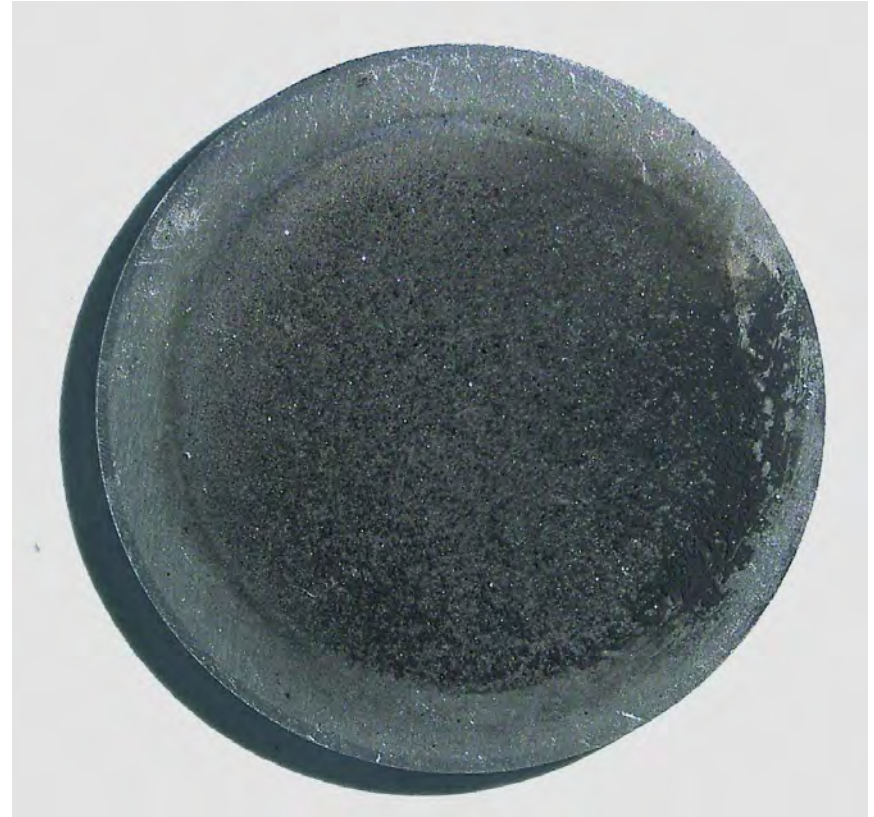
# Witness Plate Assembly : Post Test

Directly exposed (B2)

Protected under Whipple plates (D2)

Directly exposed samples covered in coarse soft catch debris.  
Less material under Whipple plates

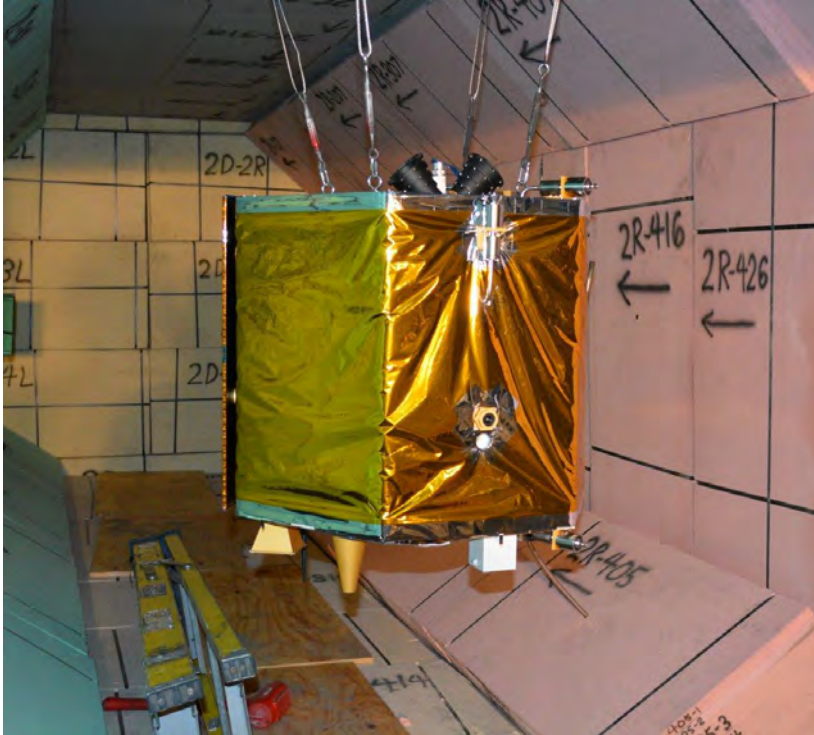
Looking down range.  
Outer surface covered with  
multi layer insulation.

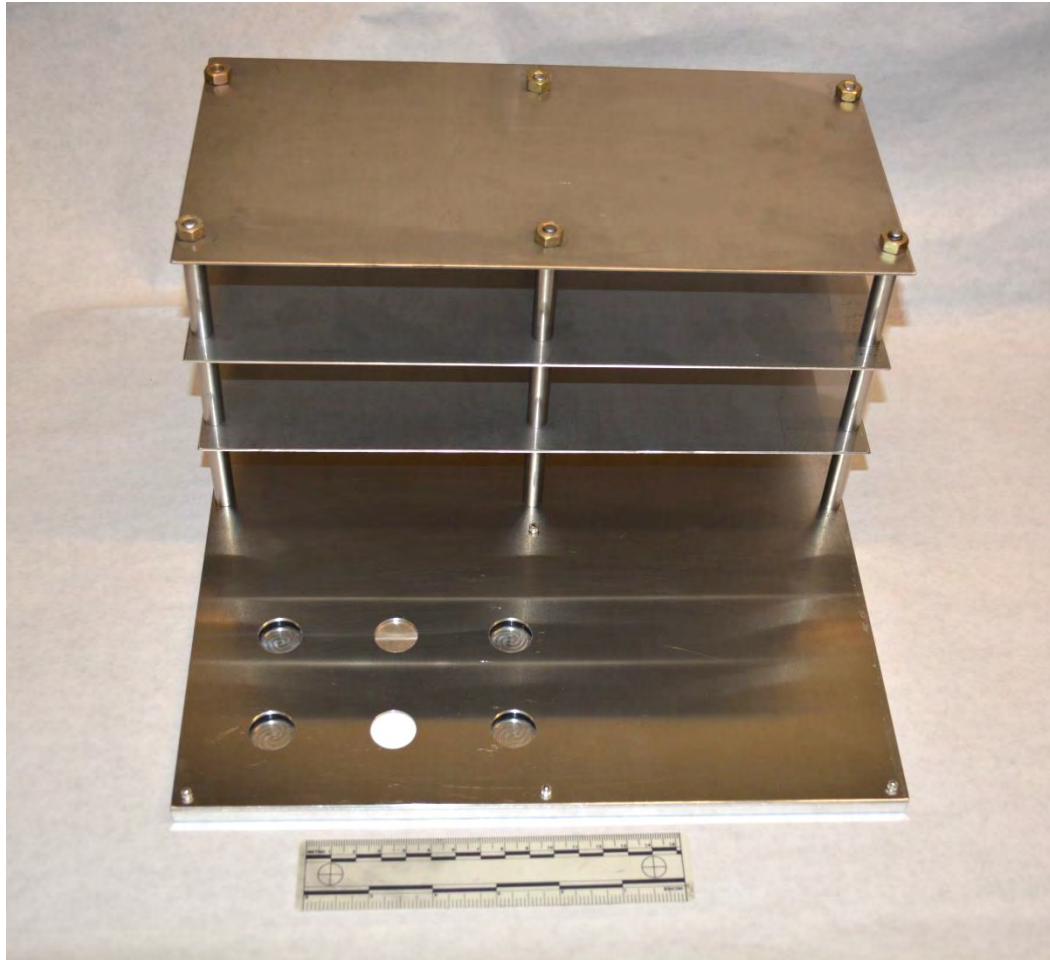
# Witness Plate: Pre Test

Witness plates located in same position in chamber as Debris-LV.  
~2-3 meters up range of DebrisSat.

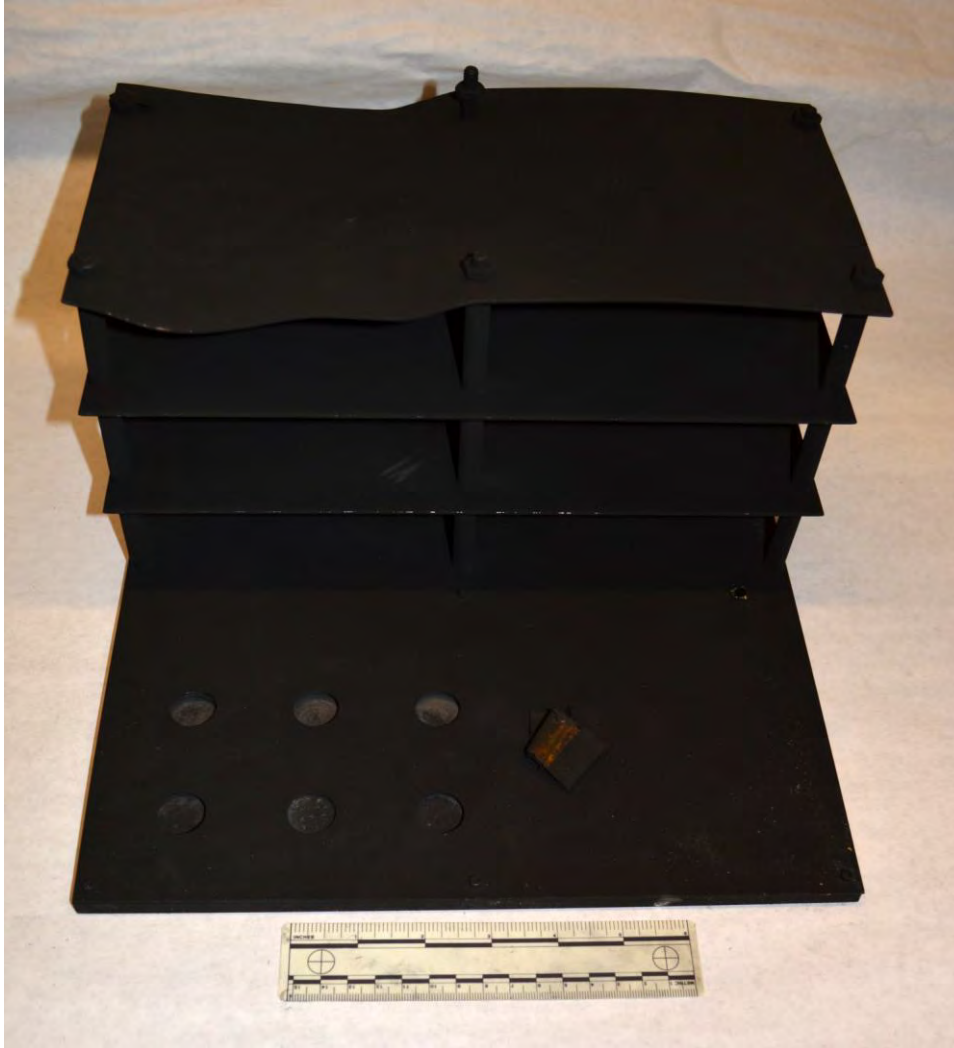
# Witness Plate: Post Test

Whipple plate received a significant impact. Many witness plate samples were fractured/destroyed.

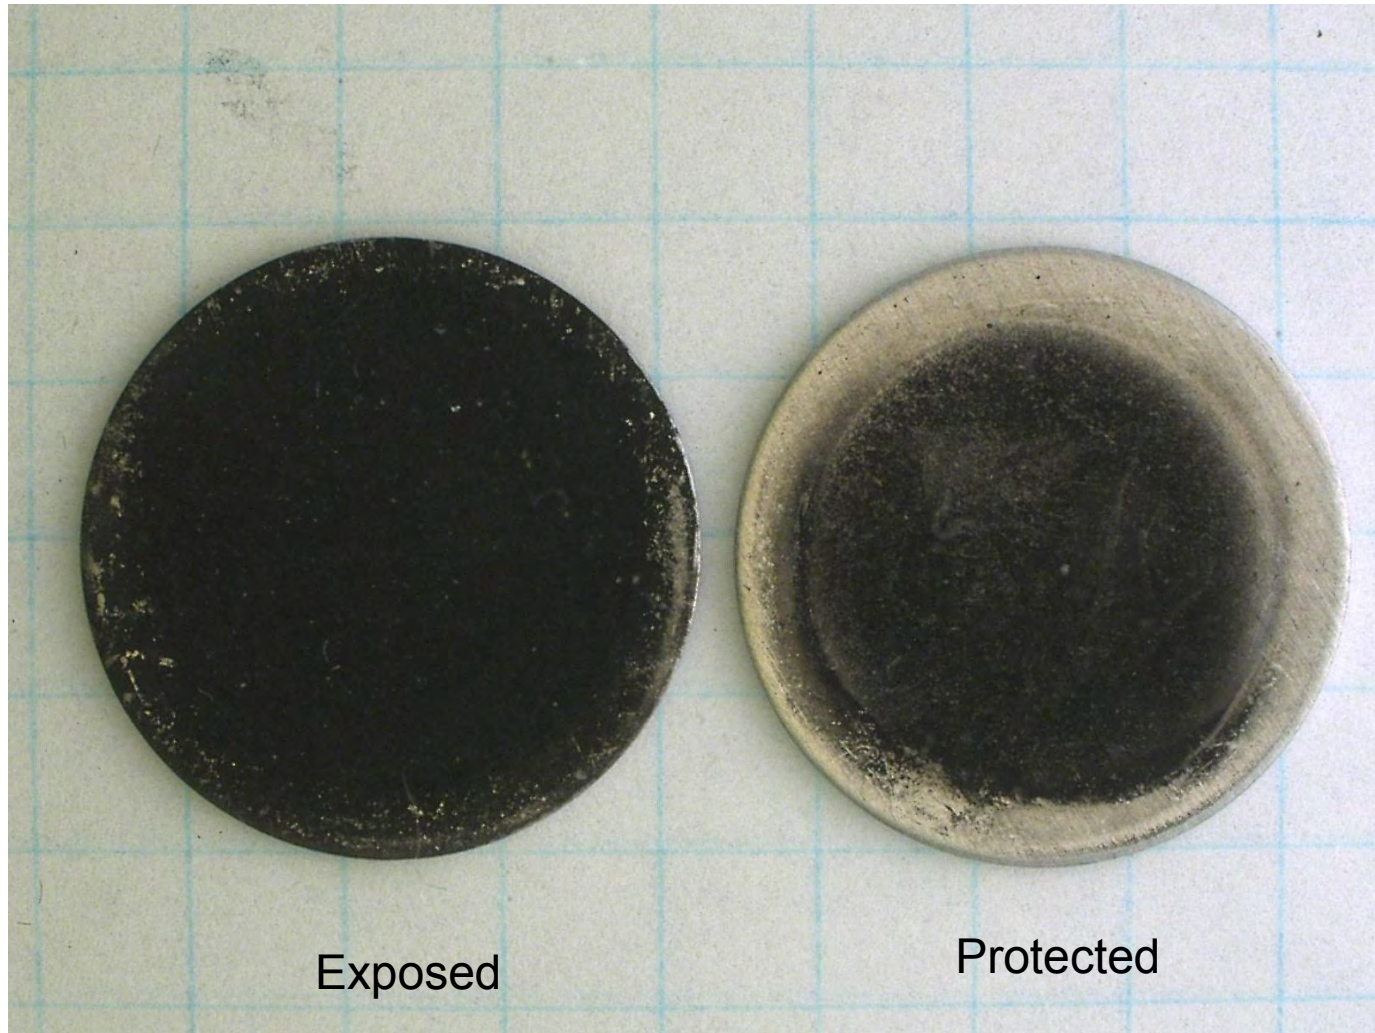
# Post Test: Aluminum Disks

Significant accumulation of debris, especially soft catch fragments on exposed disk

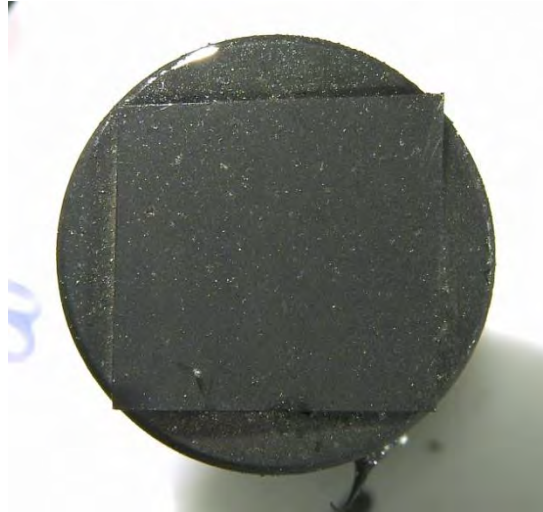
Exposed #13

Tantalum sheet on aluminum stub. Note significant darkening of post test stubs

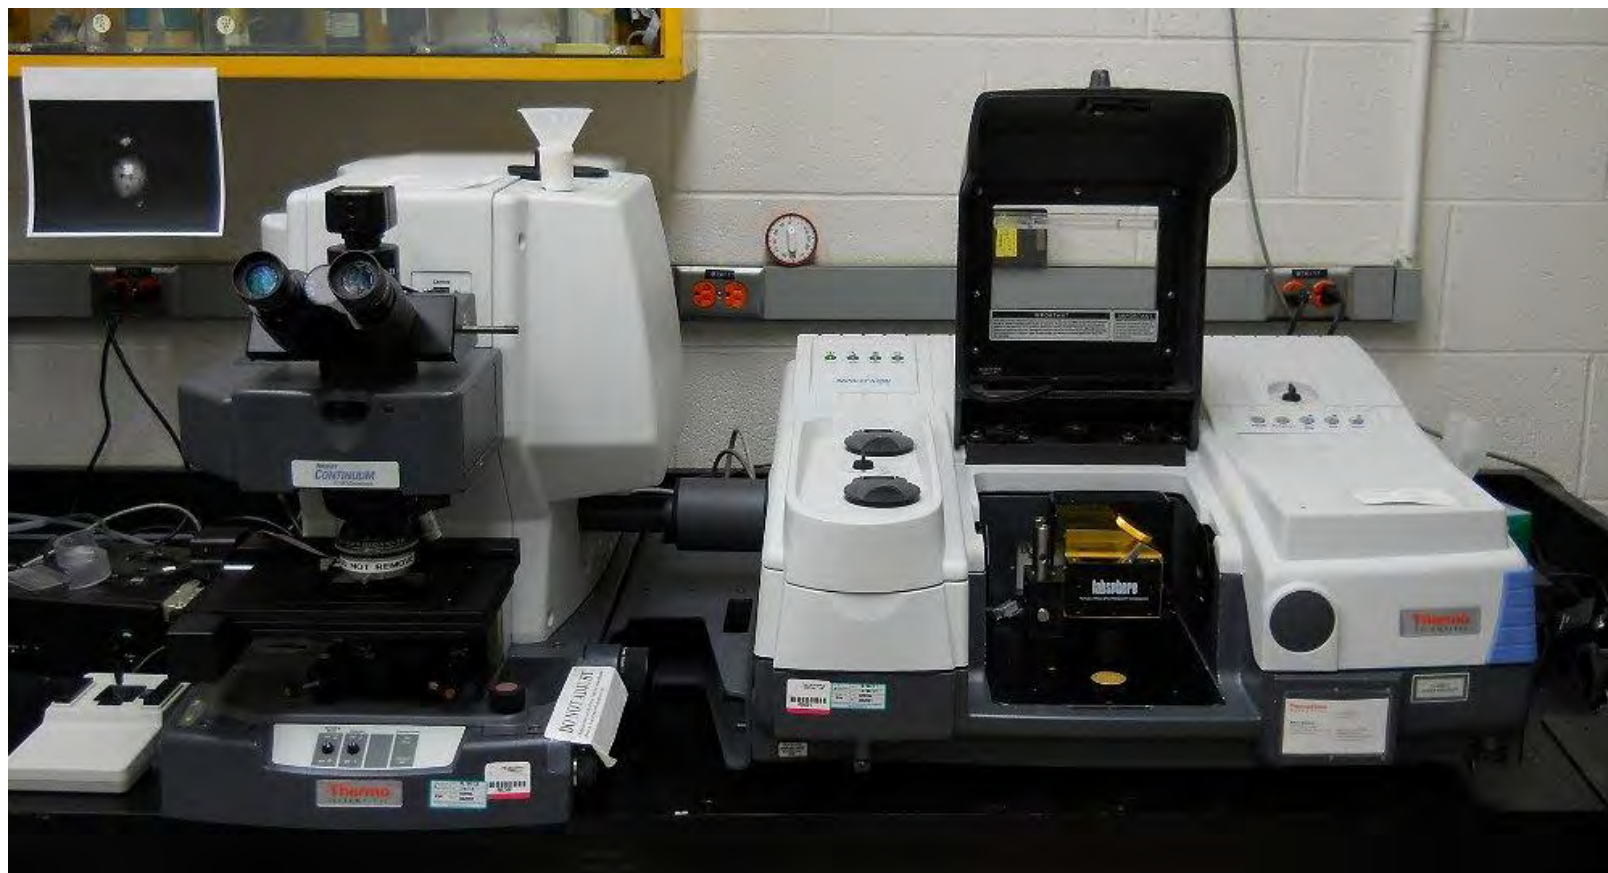
# Fourier Transform Infrared (FTIR) Spectrometer

Thermo-Nicolet 6700 FTIR and Continuum Microscope  
Labsphere integrating sphere in sample compartment at right

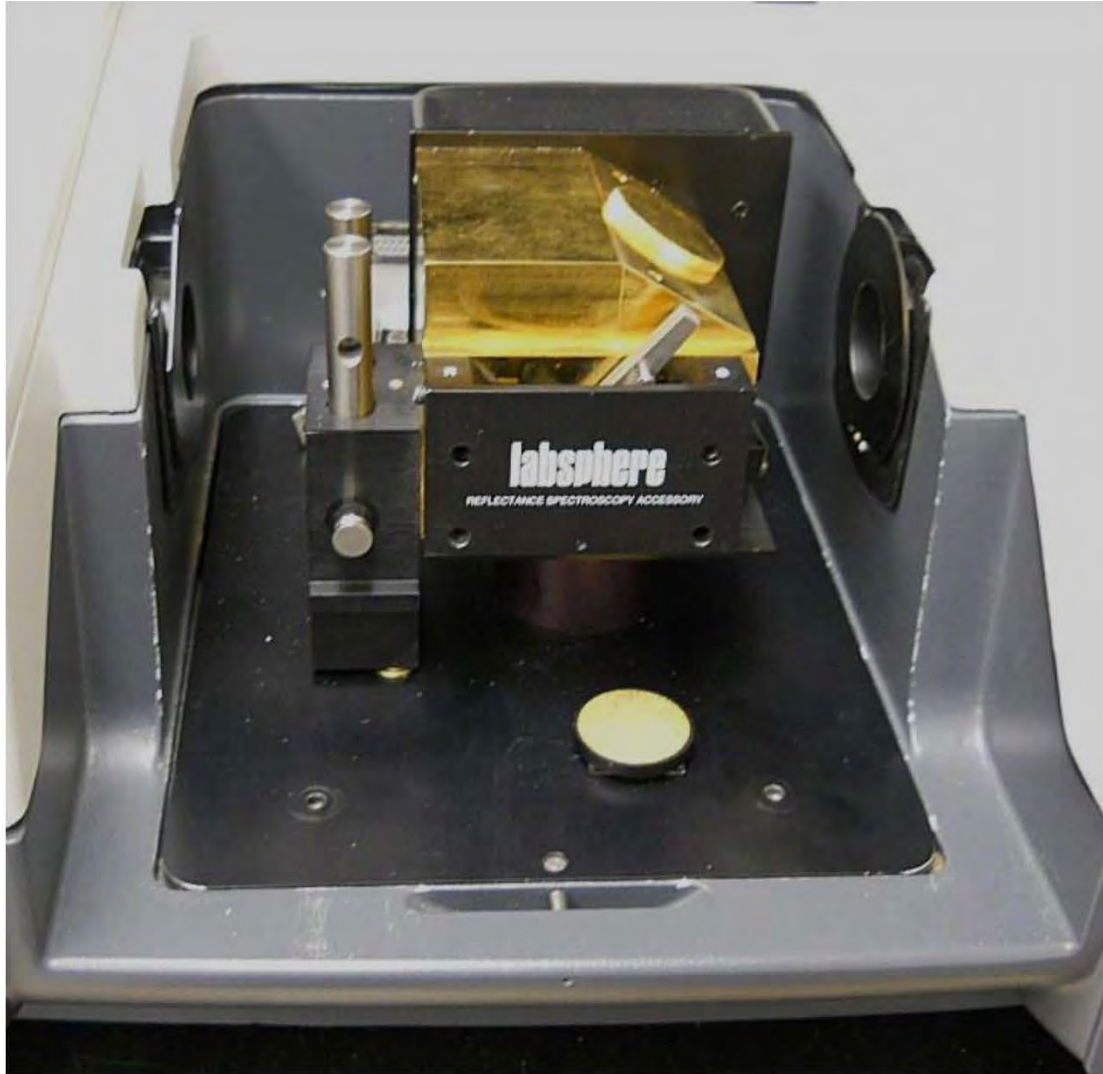
# Hemispherical Reflectance

Labsphere Integrating Sphere

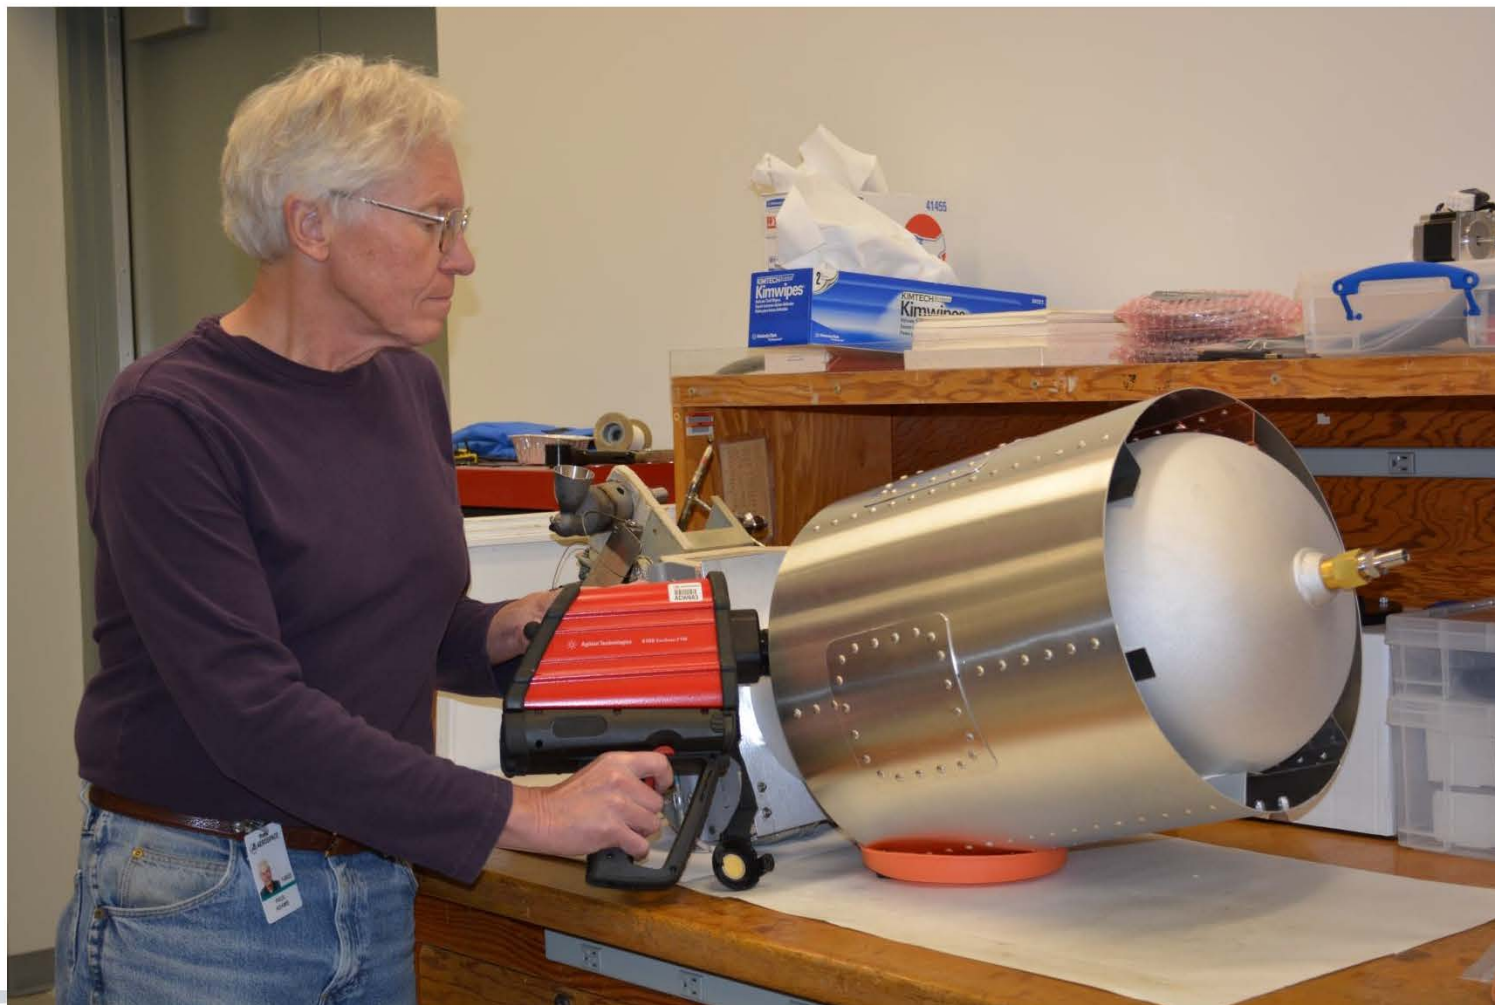
# Agilent Exoscan Biconical Reflectance

- Agilent(A2) Exoscan Portable FTIR.
- Parabolic mirror focuses beam on sample.
- Diffuse reflectance head uses diffuse gold as reference.
- Spot size about 5 mm.
- QUALITATIVE reflectance measurements ONLY.
  - Generally can only analyze relatively flat samples.
  - Must make contact with sample.
  - Reproduces spectral shape for material identification.
  - Reasonable signal to noise in a short period of time.
- Typical scans:
  - 4000 – 650  $\text{cm}^{-1}$  (2.5 – 15.4 microns).
  - 4  $\text{cm}^{-1}$  resolution
  - Scan time 30 seconds.
